RE: Ellwood Mesa Trails Follow Up

At your request and on behalf of the California JPIA, we visited the Ellwood Mesa Sperling Preserve and Butterfly Habitat on Tuesday, July 11<sup>th</sup>. The purpose of our visit was to review the condition of the preserve's extensive network of trails in response to the findings of a recent independent tree health study. We were joined by several members of the City's Maintenance and Parks and Recreation Departments, as well as a certified arborist. Please thank them for their help in this evaluation.

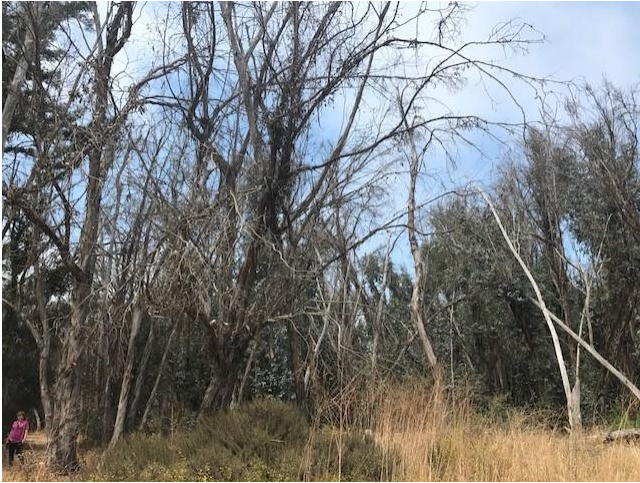
The independent tree health study referenced above found the presence of several hundred dead trees within the preserve; including trees in the immediate area of hiking and walking trails routinely used by the public ([Photograph 1](#)). Dead and dying trees pose a serious safety risk in this preserve due to their congregation in populated areas, presence of pests, potential for sudden trunk and branch falling, and risk of bringing additional trees down with them ([Photograph 2](#)).

**Photograph # 1 – Cluster of Dead Trees**

1. Prepare an action plan to top off and remove dead and dying trees (trees marked 0 and 1); beginning with the trees located along known trails.
2. Periodically inspect the trails to identify and remove make-shift swings and encampments ([Photograph 4](#)). Ensure existing structures such as bridges, benches, and viewing areas, do not pose obvious and unnecessary risk to the public.

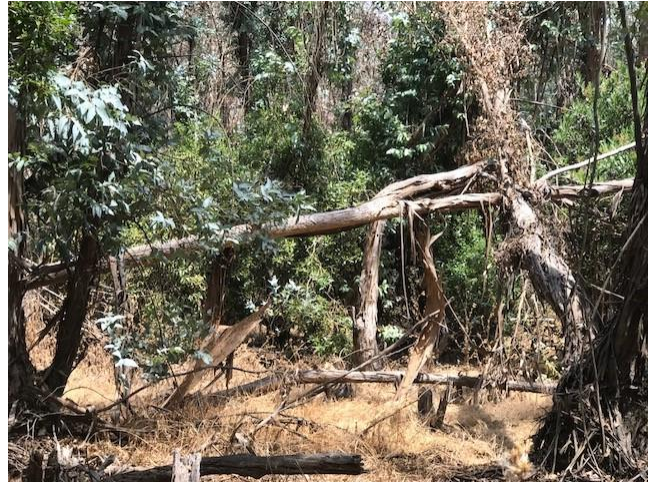
**Photograph # 2 – Fallen Tree Along Trail**

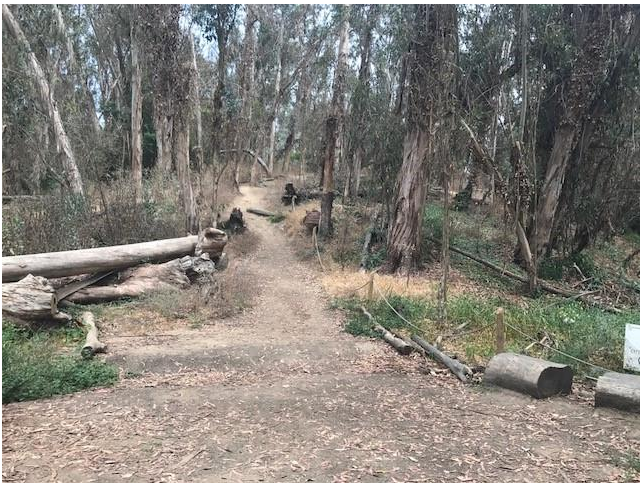
**Photograph # 3 – Trail Laden with Dead Trees**

After reviewing the study as well as the actual preserve, the city is strongly recommended to take immediate action to actively discourage the use of the area; up to and including closing certain trails with high concentrations of dead and dying trees ([Photograph 3](#)).

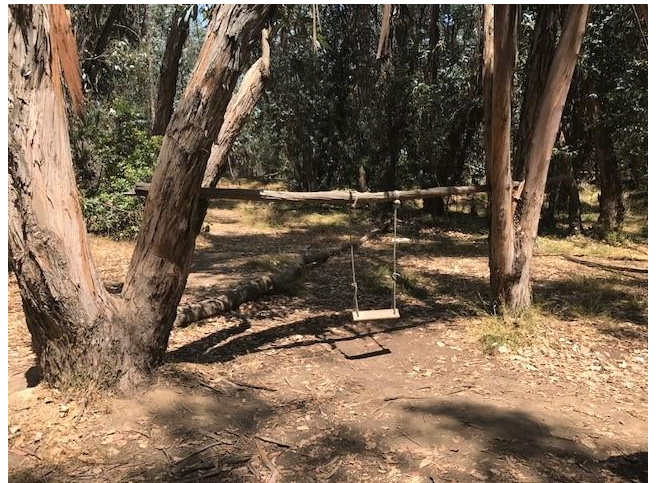
**Photograph # 4 – Make-Shift Swing**

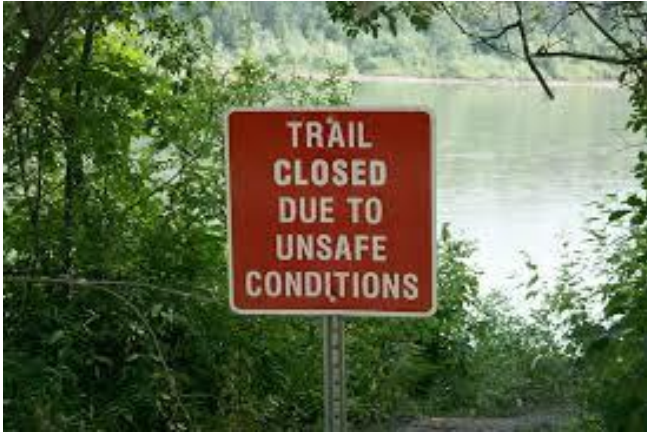
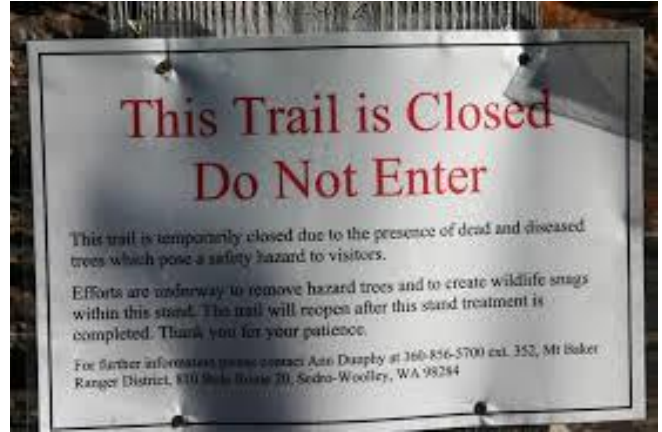
**Photograph # 5** – Trail Closure Signage

**Photograph # 6** – Trail Closure Signage

3. Install signage warning users of the hazards and potential for injury. Close certain areas that pose additional risk depending on the number and locations of dead trees. Signage should be installed and maintained at all trail entrances and in both directions. See [\(Photographs 5 & 6\)](#) for sample signage.
4. Post the known hazard and trail closing on the city's website for additional notification purposes. Click here <https://www.fs.usda.gov/alerts/angeles/alerts-notice> - for the trail condition and notification site for the Angeles National Forest, who routinely close trails for similar reasons. Developing a similar site for the city will be a good way to provide due warning to the public as well as maintain a record of notifications.
