Attachment 2 – 2021/2022 Photographs

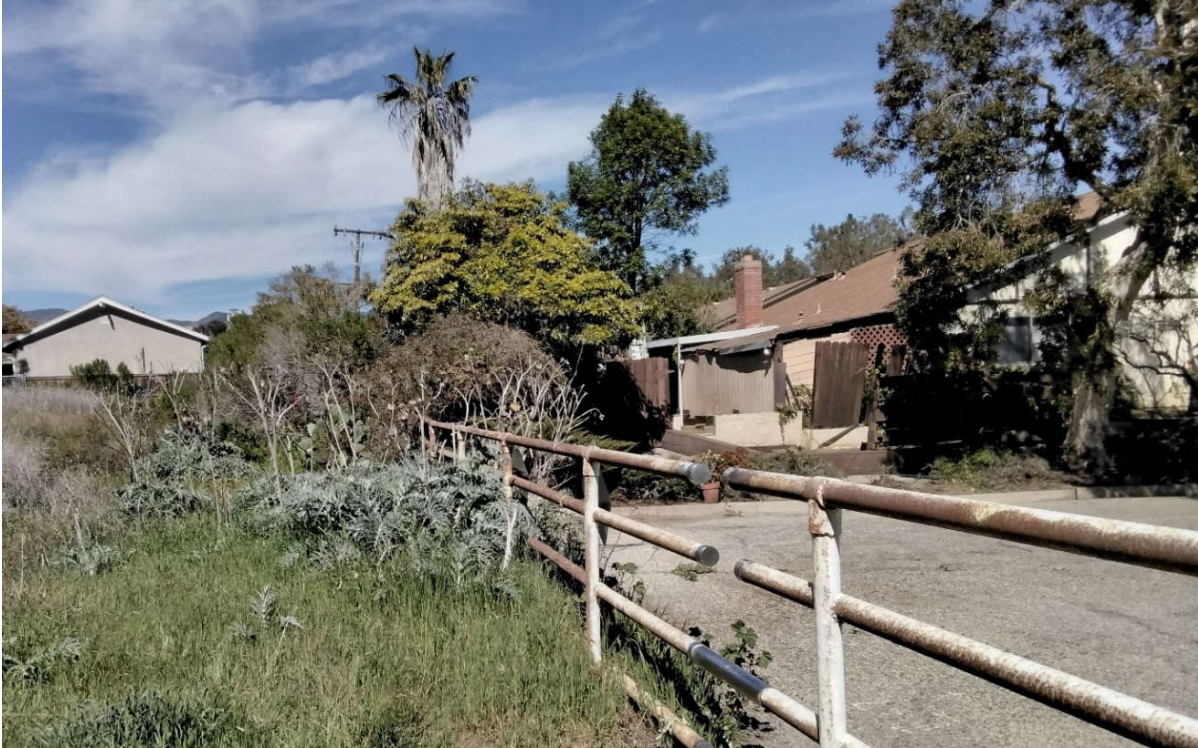
Photograph 1. View looking northeast into the Santa Barbara Shores neighborhood. High fuel load within 100 feet of a structure and over-hanging the residential fence.

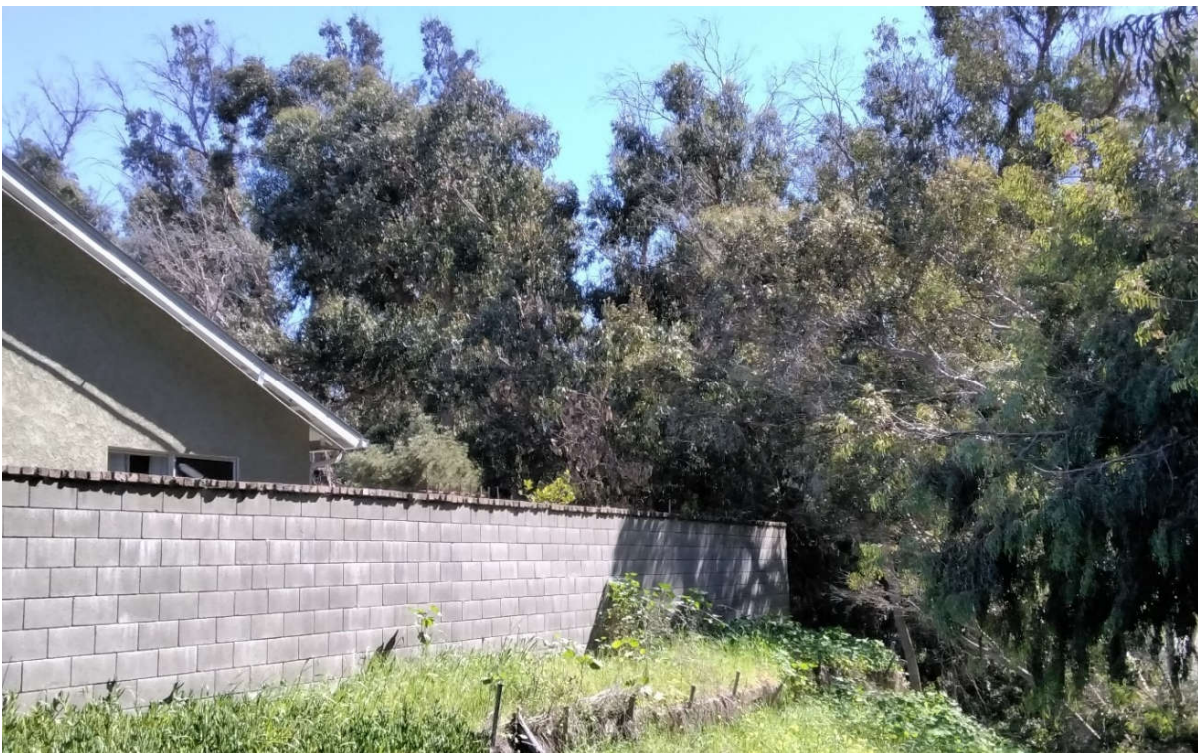
Photograph 2. View facing southeast into Santa Barbara Shores neighborhood near Ellwood Main monarch butterfly over-wintering site. High fuel load within 100 feet of a structure and over-hanging the residential fence.

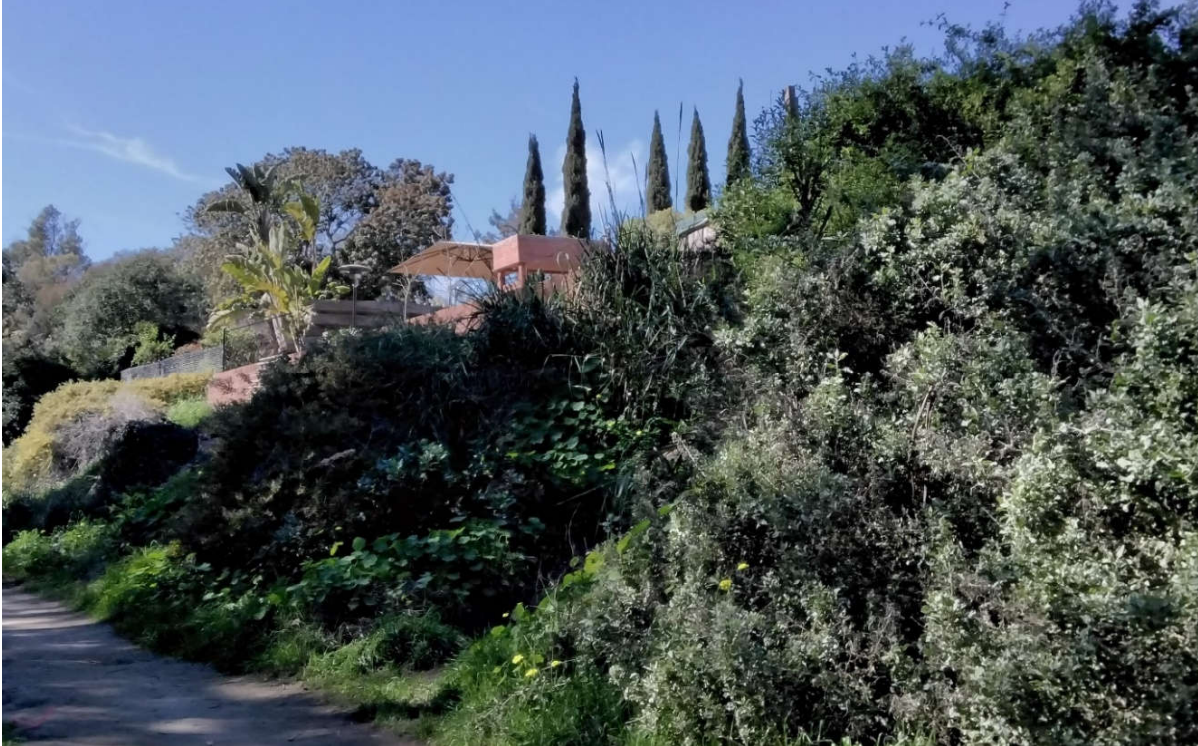
Photograph 3. View facing northwest into Santa Barbara Shores neighborhood near Ellwood Main monarch butterfly over-wintering site. High fuel load along hillside and within 100 feet of structures.

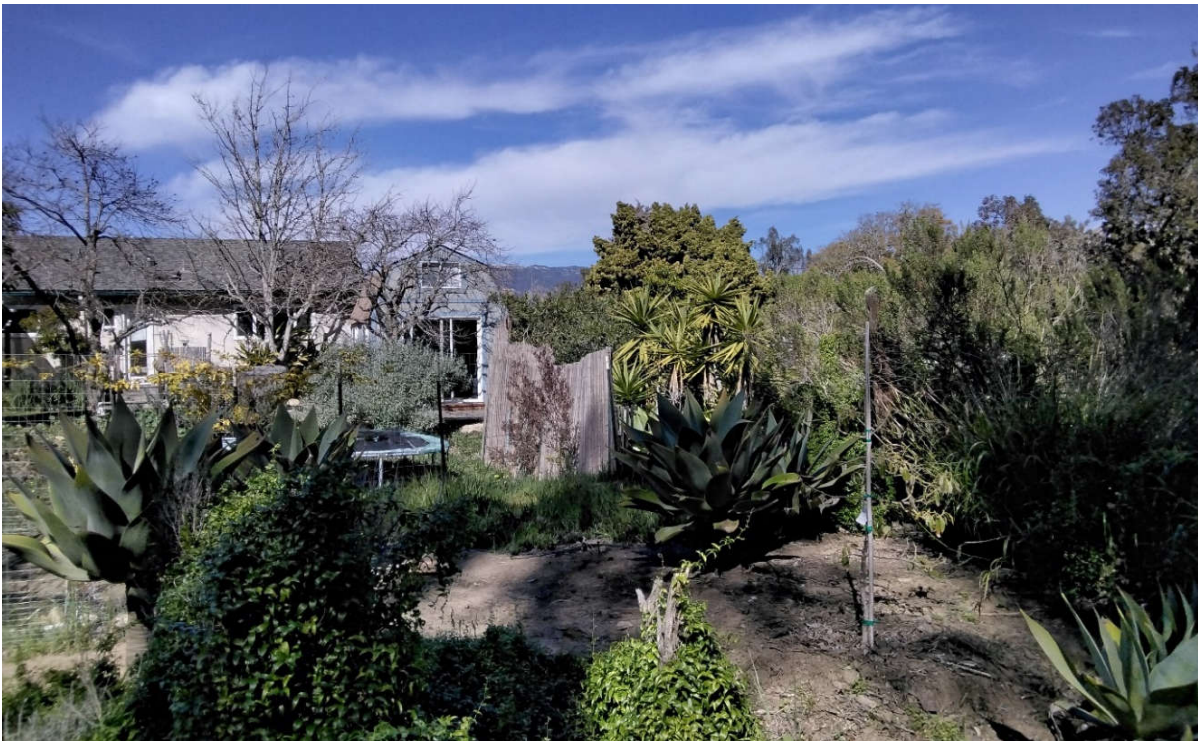
Photograph 4. View facing northeast into the Santa Barbara Shores neighborhood near Ellwood West monarch butterfly over-wintering site. Ornamental landscape and dense native vegetation within 100 feet of structures.

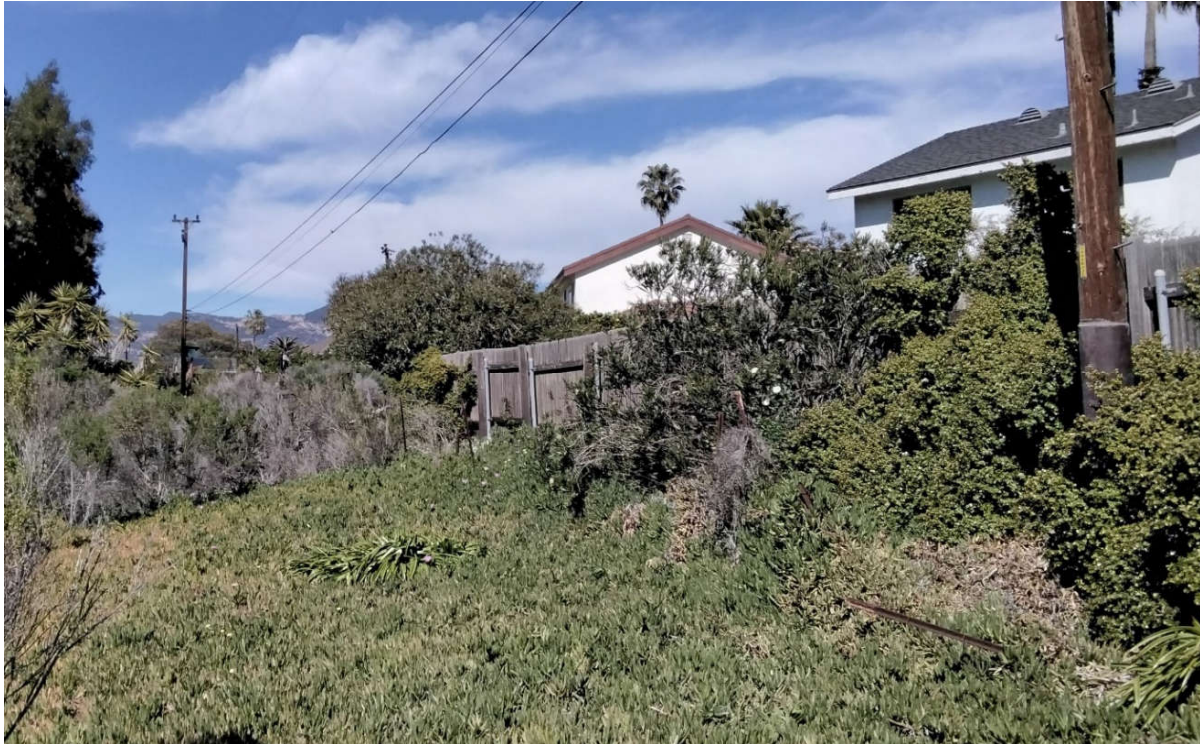
Photograph 5. View facing northeast into the Santa Barbara Shores neighborhood and Ellwood North monarch butterfly over-wintering site. High fuel load along fence line and within 100 feet of structures.

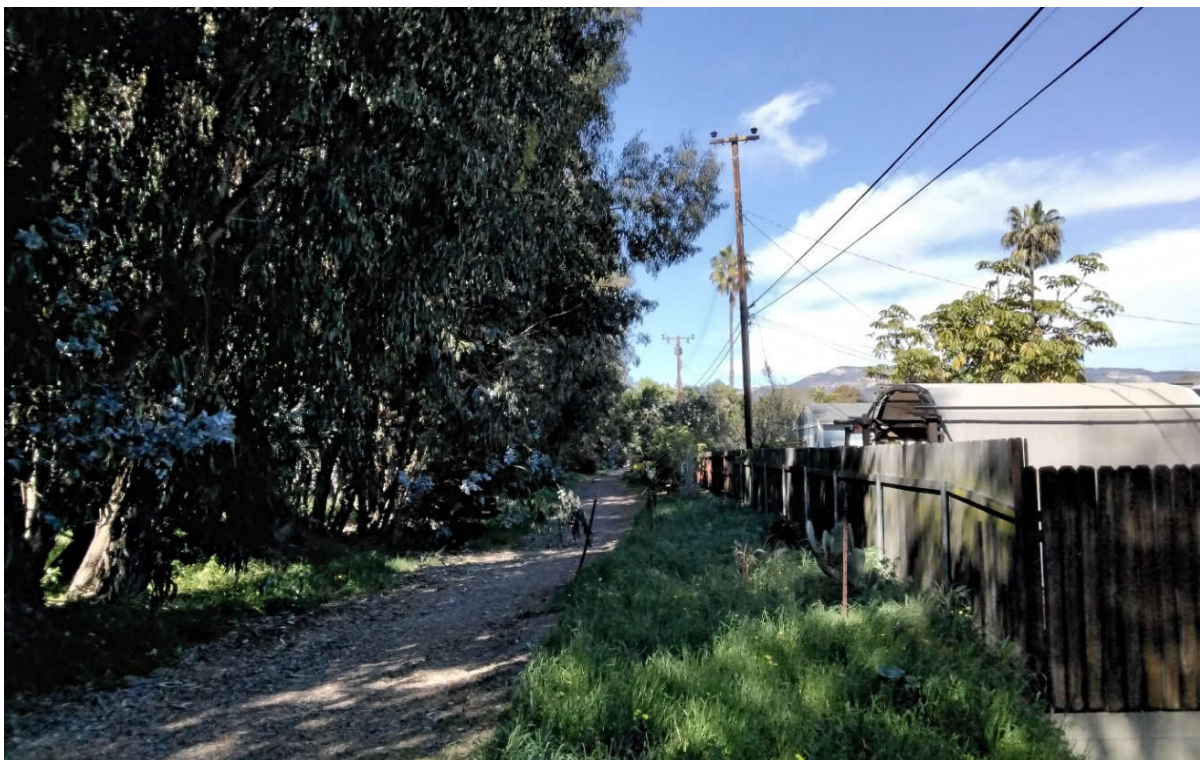
Photograph 6. View facing north into Santa Barbara Shores neighborhood and Ellwood North monarch butterfly over-wintering site. Eucalyptus branches overhanging property lines and within 100 feet of structures.

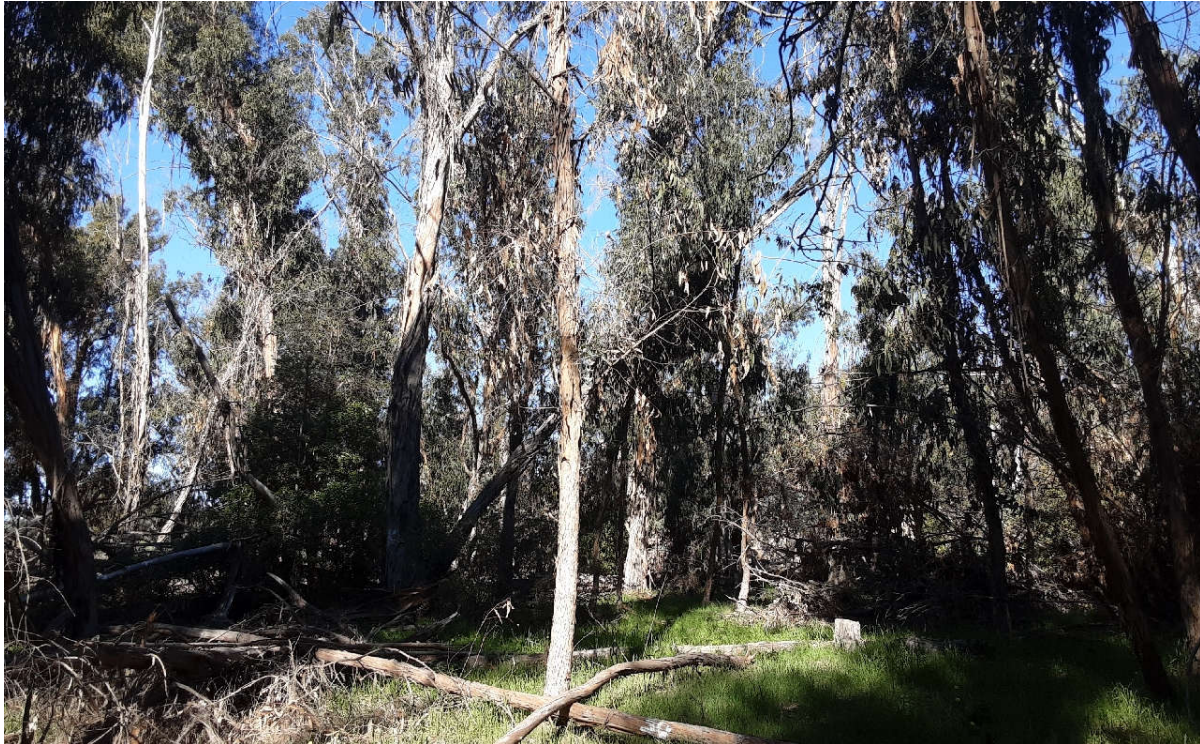
Photograph 7. View facing north into Ellwood North monarch butterfly over-wintering site. Dry, dense shrubbery and hazardous trees create high fuel load potential within monarch aggregation site.

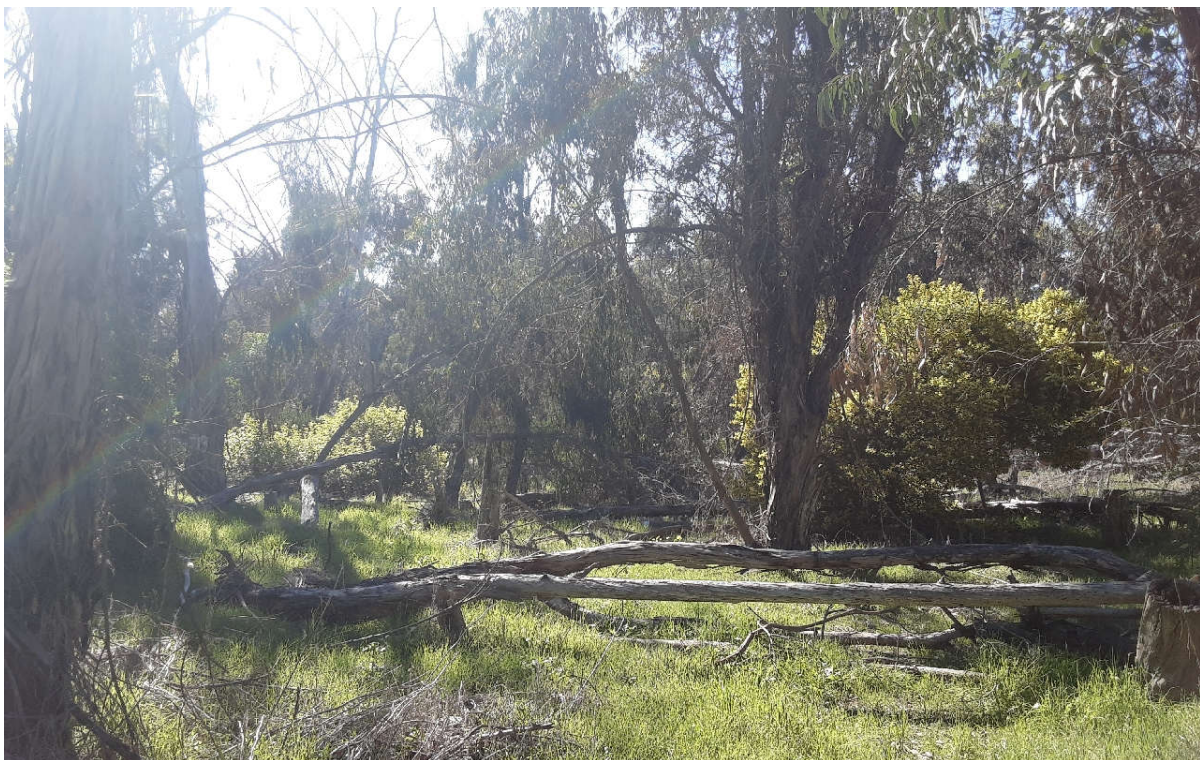
Photograph 6. View facing south at the north end of the Ellwood North monarch butterfly over-wintering site. Downed and dead Eucalyptus trees create high fuel load within the grove near monarch aggregation sites.
