BACKGROUND REPORT #16

Geology/Geologic Hazards

City of Goleta
March 19, 2004

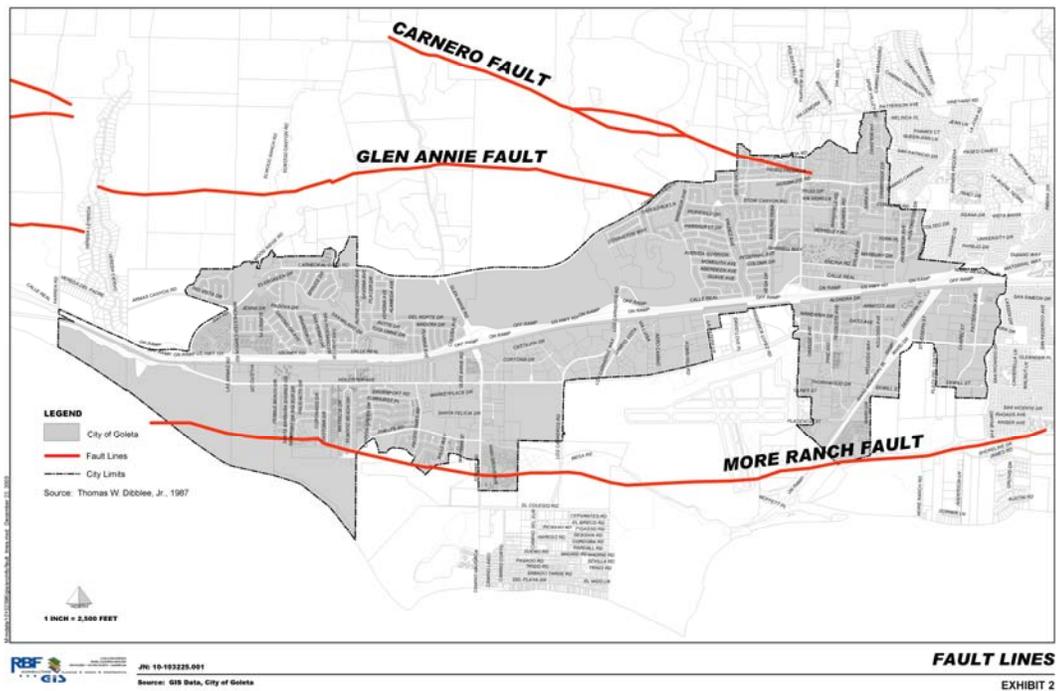
Insert Exhibit 2, Fault Lines

Two or more possible sets of faults occur in the area; evident in aerial photographs, they exist in part as strong linear features in the more competent bedrock. Exhibit 2, *Fault Lines*, illustrates the faults in the area; none of the faults shown on Exhibit 2 have been designated as active through the creation of an Alquist-Priolo special studies zone. However, several faults are considered active or potentially active based on criteria outlined in the Seismic Safety and Safety Element (SSSE)(County of Santa Barbara, 1979) of the Comprehensive Plan and by the California division of Mines and Geology (CDMG). Faults that are considered active (those which exhibit historic seismicity or displace Holocene deposits) include the More Ranch (5.8 maximum credible earthquake Richter scale) and Mesa faults (5.0 maximum credible earthquake Richter scale).

San Jose and Goleta faults are considered potentially active (having no historic seismic record and displace Pleistocene but not Holocene strata).

The SSSE considered the following faults in the Goleta area as inactive (having no record of displacement for more than 2,000,000 years): the Carneros, Dos Pueblos, Eagle, Glen Annie, Las Varas, Lavigia, Modoc, San Antonio, San Pedro and Ygnacio. Major active or potentially active regional faults, which could have an effect on the Goleta Valley, include the San Andreas, Santa Ynez, Rinconada, Nacimiento, Big Pine, Pine Mountain, White Wolf and Garlock (County of Santa Barbara, 1979).

Developments near the More Ranch and Mesa faults (both considered active) would be expected to have the most significant potential to be affected by ground rupture.
